# ICE FLOWER

# lamination process defects; how to prevent and control them

Ice flower defects on laminated glass

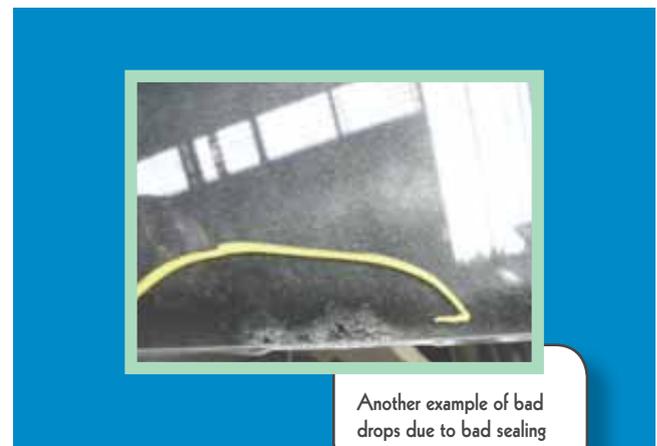
Another theory is that there is a relationship to tiny amounts of residual moisture left behind from washing process for example and is trapped between the laminate. Later under changing climate conditions, it would again activate, penetrate through the tri-layer, and form ‘ice-flowering’, arising due to high moisture. How-

ever PVB must have great moisture content to form a defect like this – that’s why it is fair to presume that small water drop presence typically is not the root of ice flowers, however water drops potentially complicate the extraction of air during de-airing, and air can remain trapped. See Figures 7 and 8 for examples. Again, in the case of the water drops, the air would be the root cause of the defect.

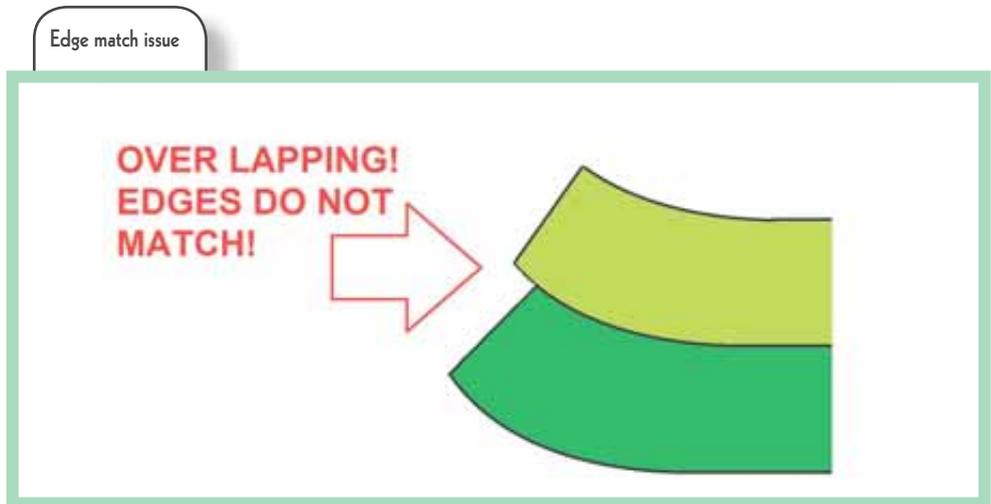
As we know, glass pair gapping is related to defects caused by residual air in the interlayer, bubbles, worms, teardrops and in the case of acoustic PVB: ice-flowers. Glass pair gapping is a characteristic that is mainly controlled in the bending process by ensuring that both glass sheets bend uniformly, but gapping can also be created at lamination works. Gapping will occur with the wrong set-up of the glass pairs. Figures ... show conditions in lamination assembly works that can create gapping between the glass pairs.

Sometimes the acoustic windshields for replacement markets are produced with a decreased amount of sagging (cross curvature), means that the bending is more flat than with the normal PVB version of the product. This alteration in product dimension is carried out to reduce the gapping that can occur due to the sag bending process. There are various recommendations about the allowed upper limit of glass pair gapping. Some claim 0.1 mm maximum, where as some allow 0.5 mm. However, it must be recognized here that gapping as a single variable is not a result of residual air causing a

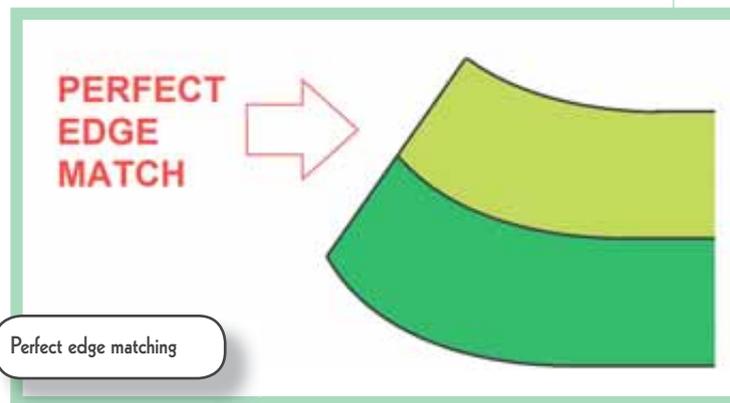
and over-the-limit manufacturing stresses at the worst conditions can cause spontaneous breakage of the windshield.

any existing gapping, cured with lamination, adds to the natural manufacturing stresses of the windshield

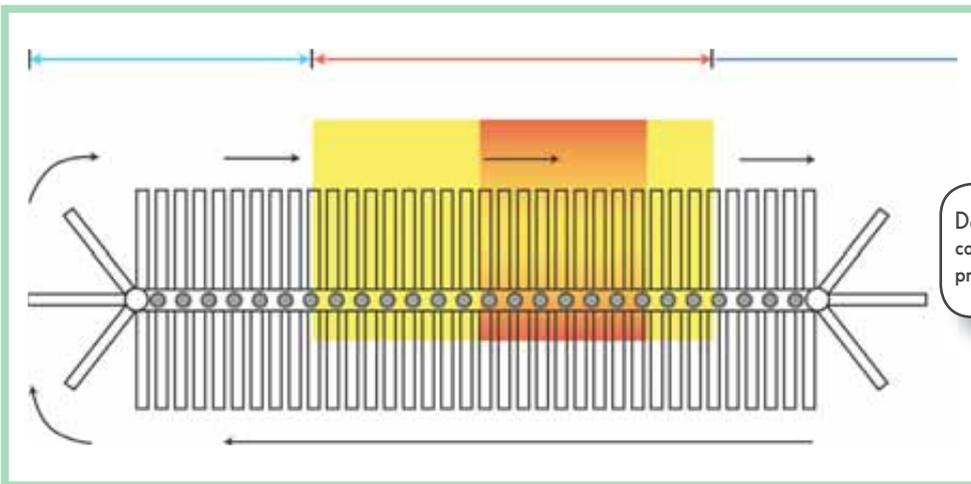
As explained earlier, the root-cause of the ice-flower defect is residual air in the laminate and that is naturally in relation to insufficient air removal and premature edge seal during processing, therefore de-airing is a paramount step when processing acoustic PVB interlayers.

Make sure that the correct vacuum ring vacuum level is reached, typically at -08 to -0.9 bar. After the vacuum is started the sandwich should be subjected to sufficient cold vacuum time to prevent premature edge seal. See the above Figure for the illustration of de-airing process stages. Cold vacuum should be maintained for a minimum of >10 minutes. Larger windshields require even longer cold vacuum time. Cold vacuum

passed the laminate will be subjected to heating. Usually most common reason for the appearance of ice flowers/snowflakes is processing default at the very beginning of the heat treatment (hot-vacuum) allowing the glass edge to seal too early. Therefore to ensure that no premature edge sealing takes place, the hot de-airing heating phase should be conducted gradually and uniformly to relieve all excess air from the sandwich. Vacuum must be maintained through the entire heating period. The glass is heated to approximately 90-110°C and to do this, the de-airing conveyors' heating settings are approximately at 120-130°C depending on the equipment used. Heating time depends on the equipment, but is typically around 20 minutes in

After the glass has passed the heating section it should be cooled down before the removal of the vacuum rings; note the cooling stage at the conveyor. The vacuum rings can be removed when the glass temperature is <80°C. Removing the vacuum rings from cooled glass prevents edge seal from opening. Therefore recommended cooling time is at >5 minutes depending on the used equipment and factory ambient conditions.
